PLANT POWER FAILURES: CASE STUDY OF INDIRECT EFFECTS ON A WORLDSCALE OLEFINS PLANT

Donald F. Schneider, PE
Chemical Engineer

Stratus Engineering, Inc.
PMB 339
2951 Marina Bay Drive #130
League City, Texas 77573
(281) 335-7138
Fax: (281) 335-8116
e-mail: dfsstratus@aol.com

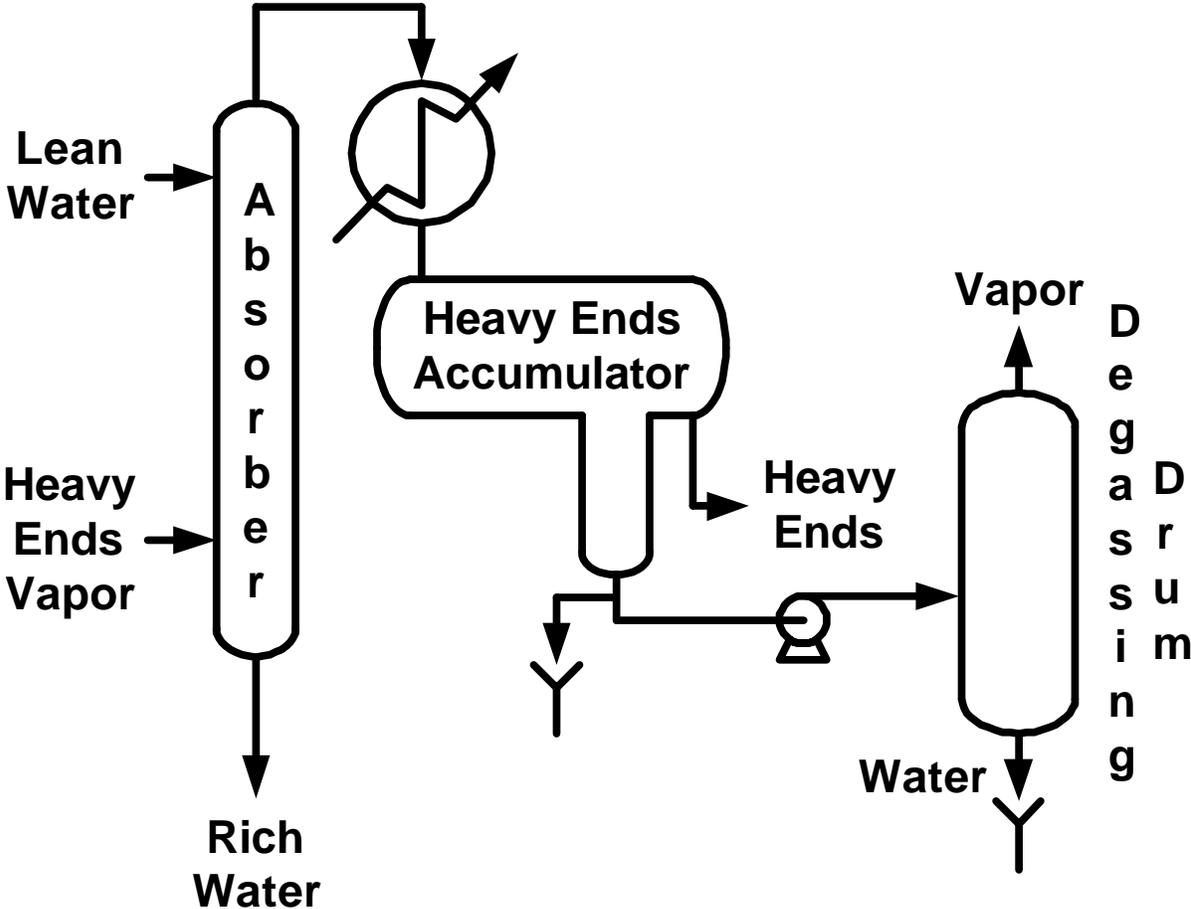
Figure 4 - Butadiene Plant Heavy Ends Recovery

Heavy Ends in the BD plant feed (1,2 Butadiene, heavy acetylenes, Butadiene dimer, C5's) are continuously removed by a drag stream pulled from the BD Unit solvent stripping section. After being stripped from the solvent laden drag stream, the Heavy Ends are water washed to remove ACN traces and then condensed. Figure 4 illustrates the Heavy Ends Absorber and Accumulator. The Heavy Ends Accumulator is the lowest pressure vessel in the BD plant. The Accumulator boot may collect a small amount of water over time which is sent to a degassing drum using a low capacity pump. Monitoring of the Heavy Ends Composition is important as ethyl and vinyl acetylene are rejected in this stream. Acetylene concentrations greater than 30 to 40 mole%, depending on the species, can become unstable.

Unidentified at the time of the restart, an unusual mixture of water, ACN, and C4's had made its way to the BD plant's Heavy Ends Accumulator during the power failure. A combination of equipment high liquid levels and columns at relieving pressure had forced the odd blend to the point of lowest pressure in the plant - the Heavy Ends Accumulator. To the level instruments and sight glasses of the Accumulator and its boot, the vessel appeared to be completely full of water. To the unit operators, the instruments appeared to be accurate.

As the day wore on, additional samples were gathered and analyzed. Operator logs and instrument system data were reviewed. Theories were developed and examined. In the early afternoon a picture of what probably happened became clear. Following the crash of the power outage, the BD Heavy Ends Accumulator had an unusual amount of water in it lifted from the Absorber bottoms. However, it also had a large amount of ACN and C4 hydrocarbons. The piping and vessels associated with the Heavy Ends system are such that high liquid levels in upstream distillation columns could allow stripped liquid solvent to be forced to the Heavy Ends Accumulator. If this solvent was unstripped, it might contain 20-30 %wt C4 hydrocarbons. High liquid levels of unstripped solvent in the distillation columns upstream of the Heavy Ends system were one consequence of the power failure. A higher than normal pressure differential between the columns and the Heavy Ends Accumulator also occurred during the power failure when tower overhead condensing systems failed.

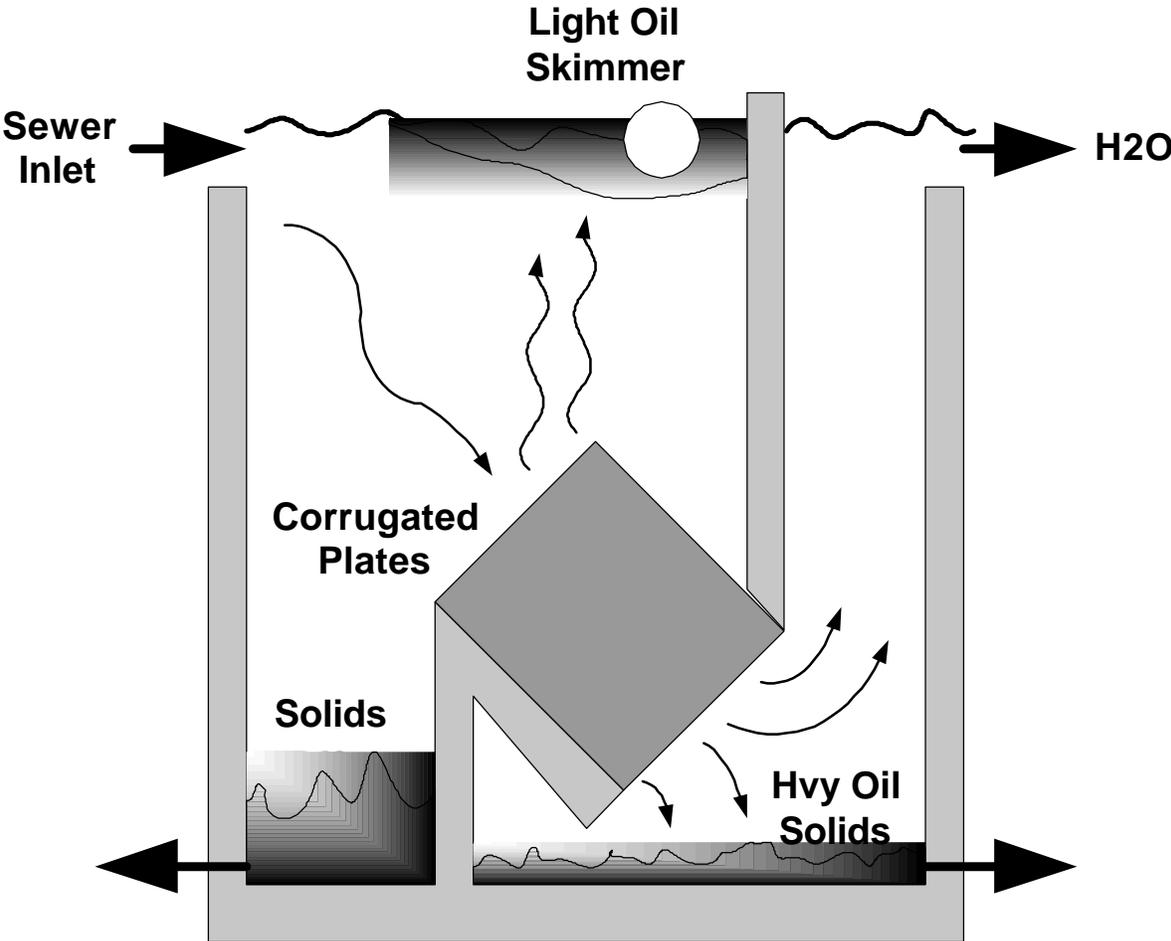
Figure 5 - Sewer Separator Simplified Layout

Figure 5 illustrates a typical corrugated plate interceptor sewer separator. Oily sewer water gravity flows into the covered, below ground compartments. As the inlet mixture passes through the corrugated plates hydrocarbons lighter than water coalesce and float to the surface of the first section where they are removed by a skimmer. Hydrocarbons heavier than water also coalesce across the corrugated plates and sink to accumulate in the outlet partition. The remaining clarified or recovered water is pumped from the outlet compartment to the bio-treaters. The bacteria at the bio-treaters, while amenable to consuming hydrocarbons, thrive on a consistent diet. Concentration swings in the bacteria's food, or the introduction of poisonous contaminants, can reduce the bio-treater's capacity through destruction of portions of the bacteria colony. A facility constipates quickly when it cannot process effluent water.

Due to the power outage, or in response to it, the recovered water pumps at the sewer separator were out of service as the relieving boiler feed water arrived. Sewer and separator fluid levels rose and, combined with the relatively high temperature of the water, generated an atmospheric odor spreading from the separator. This alerted operators to a problem. They quickly found and corrected the boiler feed water relief. They also gathered air samples for analysis. Benzene in air concentrations in excess of the 1ppm 8 hr time weighted average limit and exceeding the 5ppm 15 minute short term exposure limit were found. Portions of the C5 units near the boiler's sewer separator were cordoned off to prevent personnel exposure due to the atmospheric benzene content. Soon there would be another sewer incident.

As operations drained what they thought was water from the BD Heavy Ends Accumulator they also sent C4 hydrocarbon bearing Acetonitrile to the sewer. The C4's stayed in solution until the mixture combined with a stream which released the C4's by lowering their solubility. The sewer hub from which the spray emanated was a point of confluence for all the area's sewer lines as they fed the sewer separator. Warm water in the sewer box could have released the C4's when the solvent/hydrocarbon mixture arrived. The vaporizing

C4's lifted the gasoline boiling range oil normally present in the sewer causing the atmospheric benzene contamination.
